STATUS OF THE LAO CAI-HANOI AND PING HSIANG-HANOI RAILROAD LINES

CIA/PIR-65024

LAO CAI-HANOI RAILROAD BOMB DAMAGE ASSESSMENT

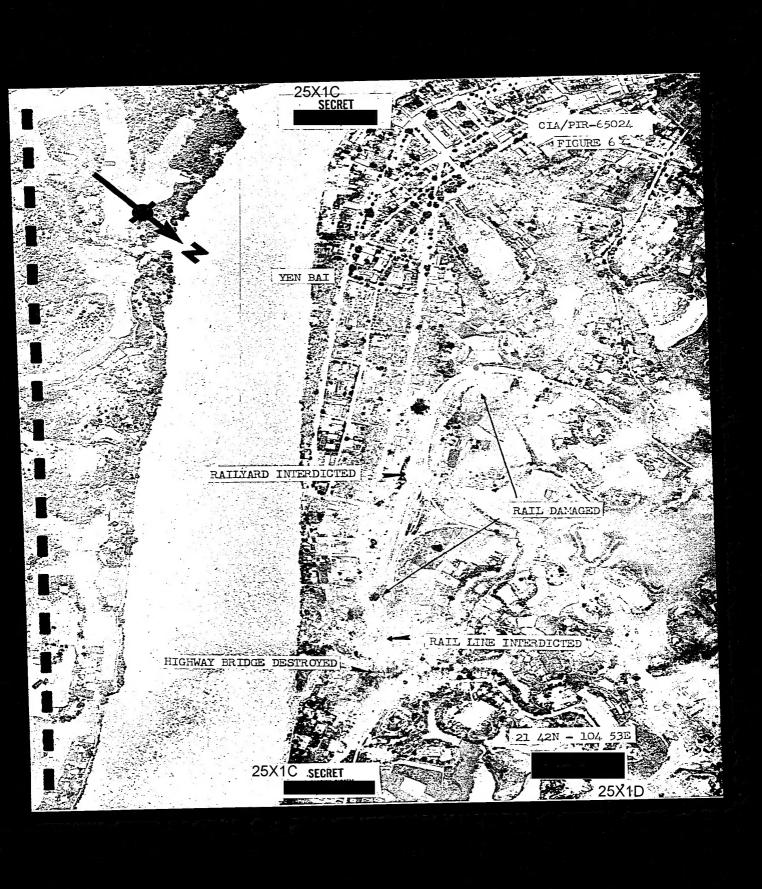
21 30N-105 03E 25X1C SECRET 25X1D

LOCATION	DESCRIPTION OF DAMAGE	NO.
25.0 Mi. NW of Yen Bai 2157N - 10437E	105 foot half-through truss and deck-girder bridge. Center span and one approach span destroyed, unserviceable. Rail line destroy-	3
20.5 Mi. NW of Yen Bai 2155N - 10439E	ed for 100 feet south of bridge. 100 foot half-through truss and deck-girder bridge destroyed	None
3.5 Mi. NW of Yen Bai 2144N - 10450E	80 foot half-through truss bridge. Severly damaged, unserviceable. Rail line destroyed for 100 feet north of bridge.	Ц.
1.0 Mi. NW of Yen Bai 2143N - 10453E	Approximately 50 feet of rail line destroyed	5·;
At Yen Bai 2142N - 10453E	Yen Bai Railyard severely damaged, unserviceable.	
16 Mi. SE of Yen Bai 2130N - 10503E	Rail line interdicted by bomb craters	7
